MARINE SAFETY INVESTIGATION REPORT

**Safety investigation into the fatality of two crew members
on board the Maltese registered chemical tanker**

KEY FIGHTER

MARINE SAFETY INVESTIGATION REPORT NO. 15/2019

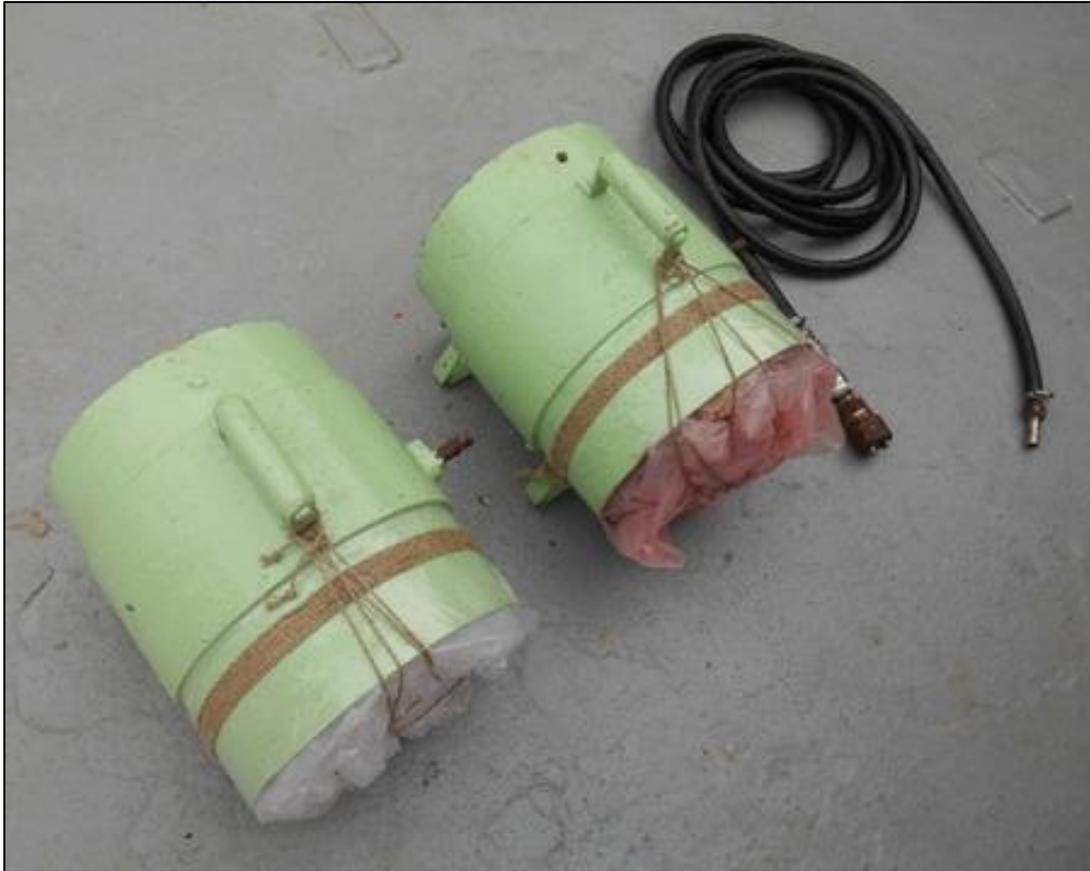
Figure 3: Portable ventilation fans

According to the Tank Cleaning and Ventilation Plan, each cargo tank required six hours of ventilation by fixed fans. On discovery of the AB and painter inside cargo tank no. 5 port, a single portable fan was found running on the deck. The plastic fan's extension hose, which would have been placed inside the cargo tank through the access hatch, was entirely on deck. This must have been withdrawn from the access hatch to allow entry inside the cargo tank. It was clear that fixed ventilation had not been in used for cargo tank no. 5 port.

- .8 Ventilation of cargo tank no. 5 port was carried out using portable gas freeing fans rather than the fixed Novenco type centrifugal fan;
- .9 The officer responsible for ensuring that all parts of the entry permit were properly completed, was available neither on deck nor in the CCR during the cargo tank cleaning operations;
